SHORELINE INVENTORY & CHARACTERIZATION SUMMARY REPORT

**TOWN OF ROCKFORD
SPOKANE COUNTY, WASHINGTON**

May 2021

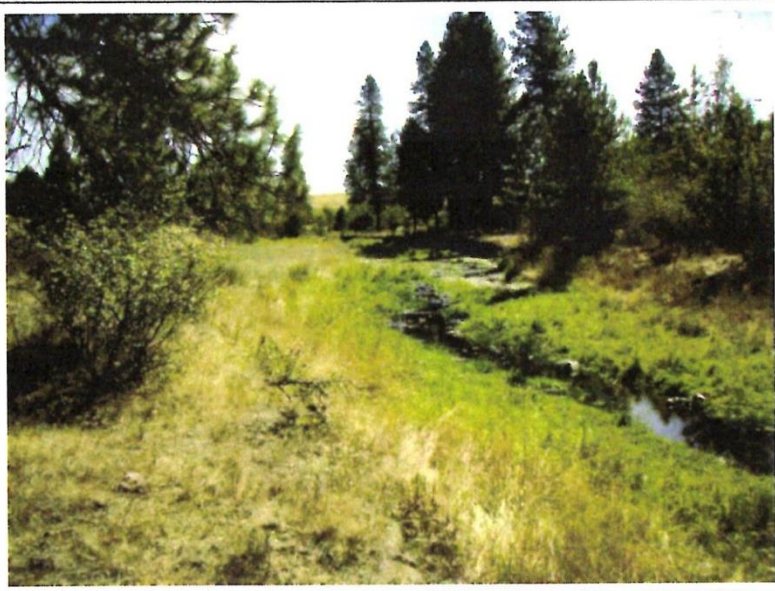
Photo No. 6	Date: 9/6/2012

Direction Photo Taken: Southeast		
Description: Stream conditions at the south end of Rockford. This area is in relatively good condition. This is the northeastern of two stream channels north of where Rock Creek splits as it enters town from the south

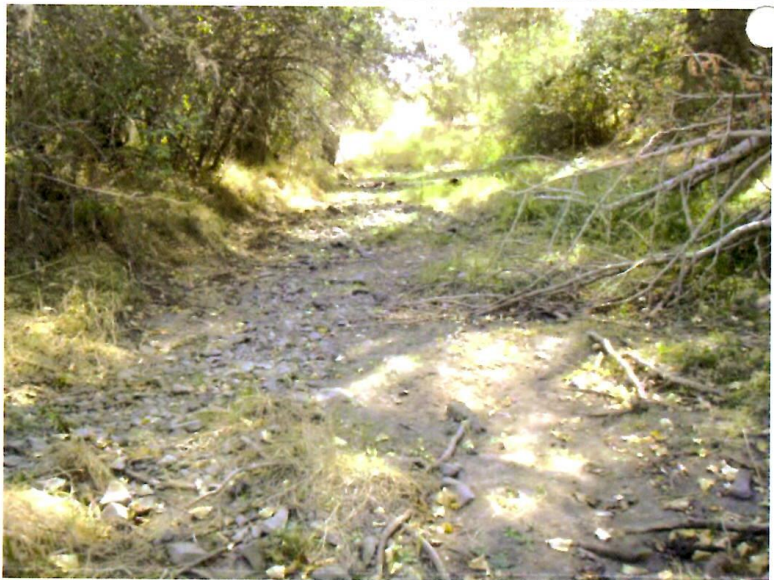
Photo No. 7	Date: 9/6/2012

Direction Photo Taken: Southeast		
Description: This is the second stream channel through the south end of town. This channel is intermittent.

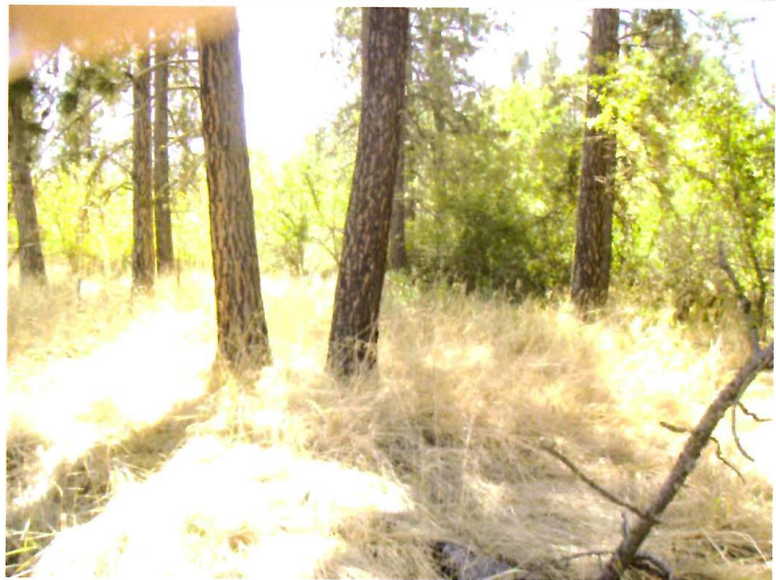
Photo No. 8	Date: 9/6/2012

Direction Photo Taken: Southwest		
Description: Conditions within a stand of Ponderosa pine near the south end of town. The stand is located on a terrace above the active channel margin

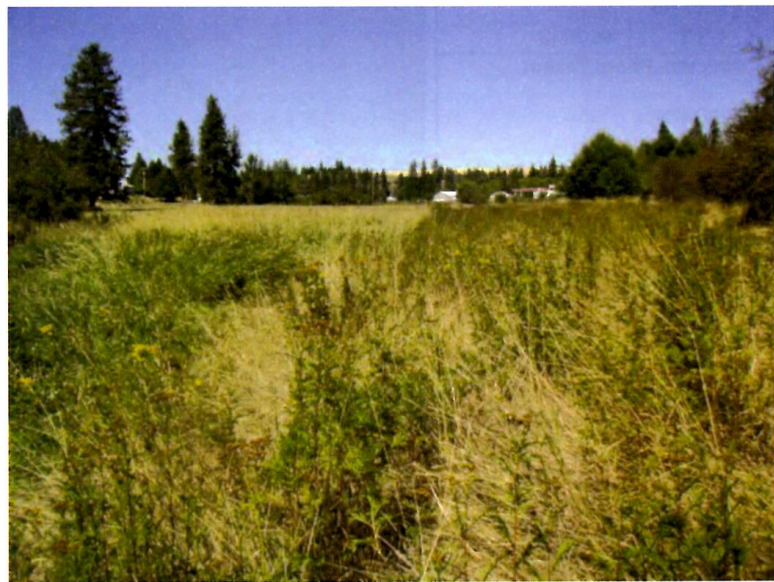
Photo No. 9	Date: 9/6/2012
Direction Photo Taken: North	
Description: Active floodplain along the right/east bank of Rock Creek. In this location the creek is heavily dominated by invasive, herbaceous vegetation. This area lacks shade-producing vegetation.

the channel becomes highly modified by flood protection levees, as seen in photo no. 9. A backwater wetland area is located along the left/west bank of the creek behind a low point in the levee. Shoreline conditions through the center of town are degraded and heavily dominated by a mixture of reed canarygrass and tansy. These shoreline conditions continue through town until the creek bends west north of the railroad bridge (Figure 4-B). After bending west the floodplain opens with an active, low floodplain terrace along the left/south bank of the creek. This area appears to contain a degraded wetland associated with a ditch. In general, the central, degraded portions of the town seem most appropriate for future shoreline development, especially along the right/east side of the creek. The natural areas at the northwest and southern ends of town seem most appropriate for habitat preservation and enhancement/restoration. Additionally, opportunities for floodplain wetland enhancement are present southeast of Church Street along the creek's west bank. In 2020, the town excavated the portion of the creek bed between the SR 278 bridge and the railroad bridge (photo no.13) This action was to alleviate future potential flooding. Eventually, flood protection may also require the rebuilding and raising of the SR 278 bridge on Emma Street.

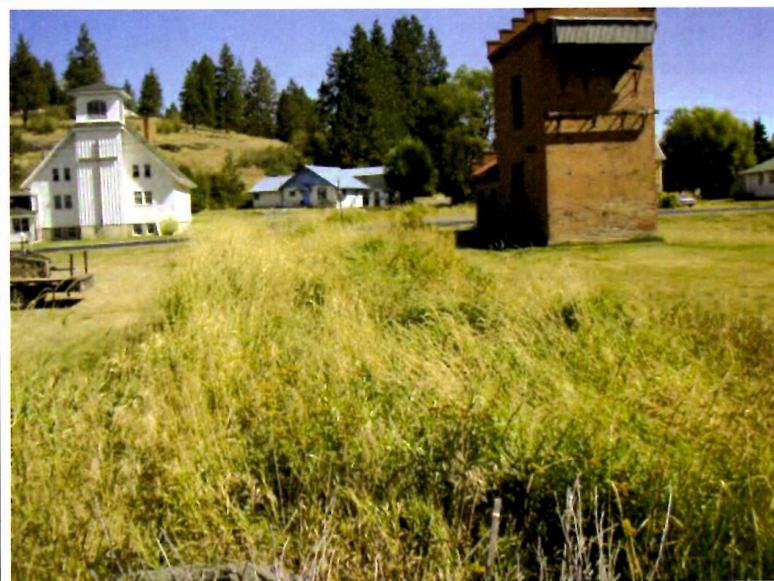
Photo No. 10	Date: 9/6/2012
Direction Photo Taken: Northeast	
Description: Photo looks up a tributary of Rock Creek that flows in a trapezoidal channel through town. The tributary has steep banks that are covered with a monoculture of reed canarygrass. A historical brick building is visible next to the creek. This building shows evidence of flooding along its base.

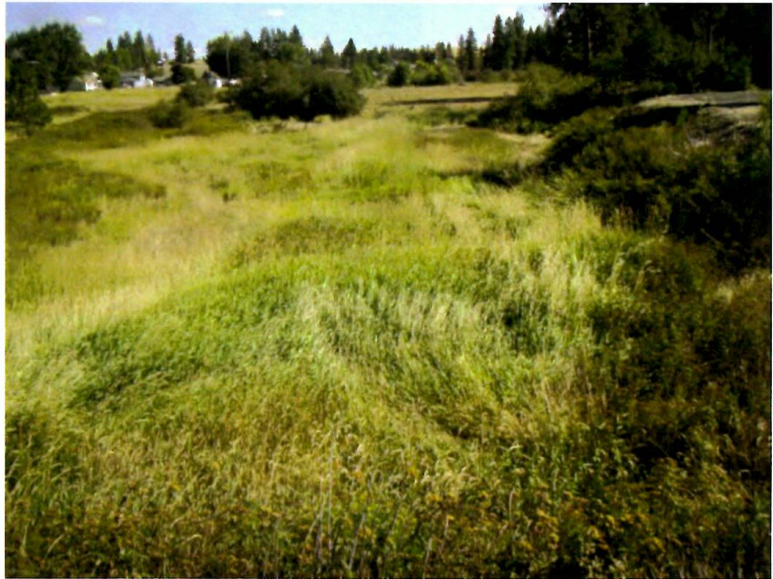
Photo No. 11	Date: 9/6/2012	 
Direction Photo Taken: Northwest		
Description: Typical conditions along the levee through town.
